**MODELS** LC26SD1EK LC32SD1EK LC37SD1EK LC42SD1EK

**Sharp Electronics (UK) Limited**

Reference – SP072004x

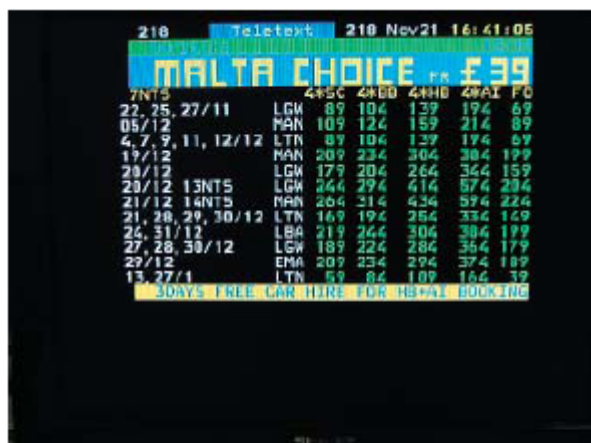
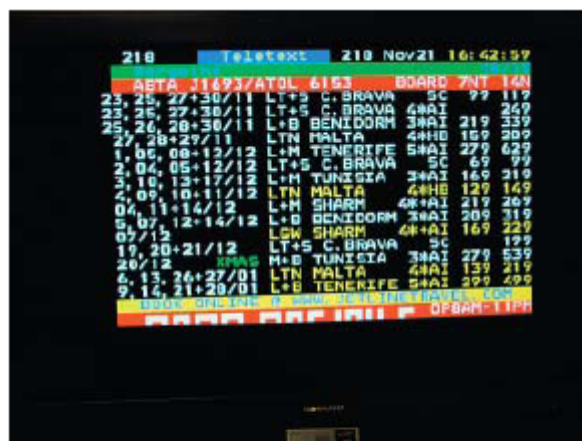
**SYMPTOM** Bottom part of analogue teletext graphics missing.

**CAUSE** Software issues for IC3002 VCT.

These images show the “Bottom half analogue teletext, missing” phenomenon.

**ACTION** Update the software for IC3002 to latest versions.
